SITE SPECIFIC REPORT SSR-2410-SHR

IMPACT LOAD TESTS, STRUCTURAL ANALYSES AND LOAD LIMITATIONS OF THE MARGINAL WHARF

TRIDENT REFIT FACILITY
NAVAL SUBMARINE BASE
BANGOR, WASHINGTON

September 1998

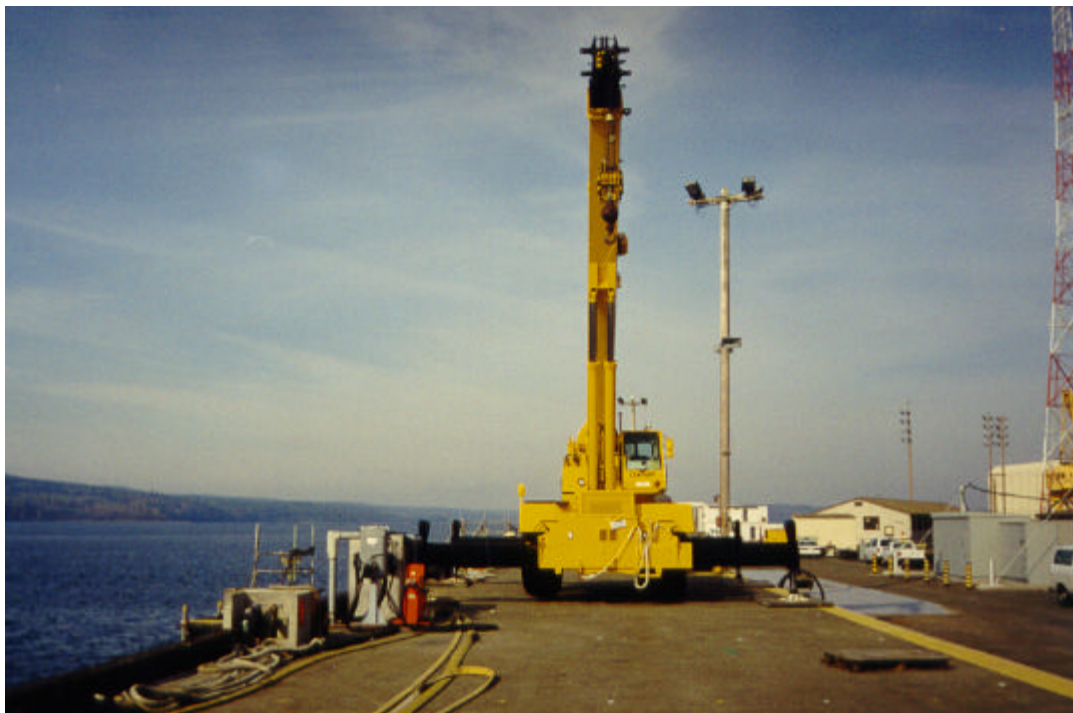
Operators of mobile cranes on the south platform place outriggers on, or near, the outside pile Lines, A and E, of the platform (Figure 7). These piles, as well as the 12-inch by 12-inch post supporting the deck above the pile caps must be maintained in excellent condition. Outriggers are placed on wood panel cribbing. While these wood panels will prevent the deck surface from being scarred by the outrigger floats, they are not sufficiently stiff to enhance distribution of the outrigger loads. To spread the outrigger load further than the floats, heavy timber or, preferably, metal cribbing should be employed. The disadvantage of proper cribbing is its heavy weight, which usually requires a forklift for positioning.

Figure 7. Truck crane on the south platform of the Marginal Wharf.

Damaged piles 42A and 64A are critically located for supporting outriggers along Line A on the outboard edge of the south platform (see Figure 7). The past two inspection reports have noted the damage and recommended replacement of the piles.

NFESC recommends that the two damaged piles along the outboard edge of the south platform be rehabilitated by encasing the damaged section in composite shells filled with nonshrink grout or mortar. It is necessary to return these piles to their original strength because maximum loaded outrigger floats are placed along pile Line A. We also recommend a crane pathway be developed over the main deck to the loading platforms. Carbon composite reinforcement can be added to the top of the deck slab over the rail girders and to the bottom of the approach slab and other slabs of the main deck that are necessary to create a path to the platforms. Main deck load capacity can be increased approximately 20 percent by addition of reinforcing over the rail girders to allow travel of all cranes except Grove RT880.

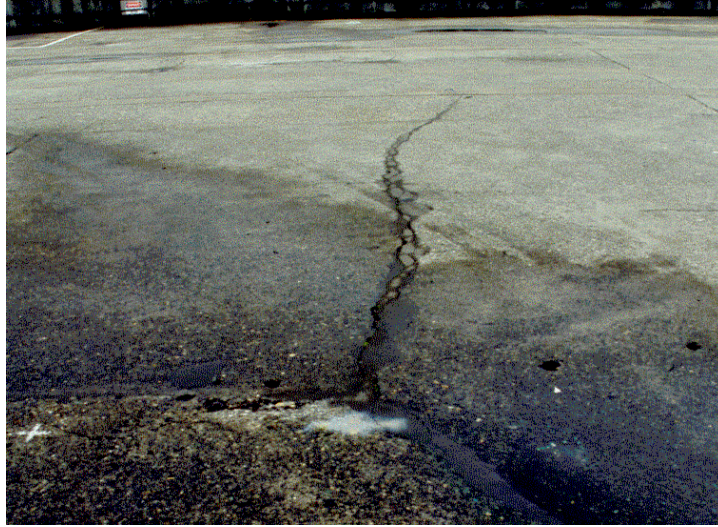
In addition to the two broken piles there are two structural conditions that could restrict the load carrying capacity of the pier deck at some time in the future. One is the presence of large cracks that have occurred because of the absence of expansion joints in the original construction (Figure 8) or structural modifications to the original deck. Large transverse crack systems occur at Bents 31, between Bents 68 and 69, and between Bents 110 and 111. Attempts to patch and seal these cracks have failed because they are working cracks and continue to widen and grow. We suspect the reinforcing bars at these cracks are badly corroded which may result in a loss of section strength. Similarly, structural modifications to the approach and the platforms have resulted in construction joints that did not integrate with the original deck slab. The “new” construction boundaries have resulted in open cracks. Exposed reinforcing bars are visible on the approach.

Figure 8. Crack emanating from approach addition (in the foreground) between bents 68 and 69.

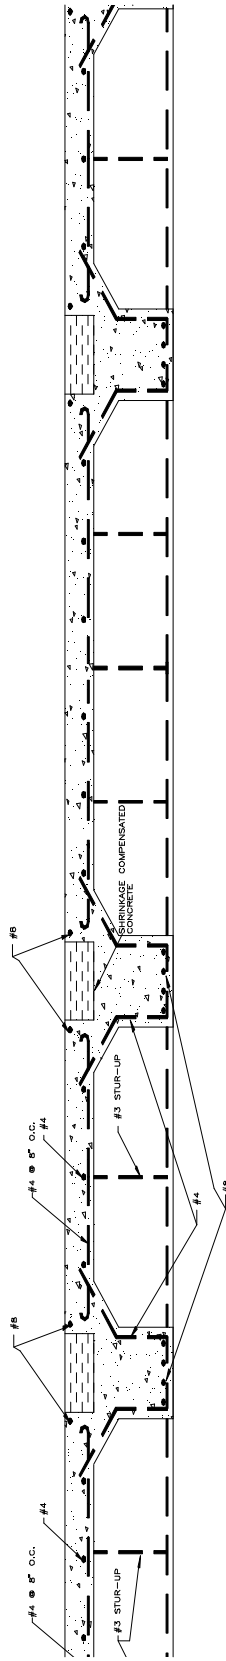
The second condition is the lack of continuity across the rail girders caused by the insertion of rails in the original construction. The train rails prevented placement of reinforcement on the top face of the slab over the rail girder in the strong bending direction (Figure 9). Longitudinal cracks over the extension of these girders on the south end of the South Pier where rails were never placed also indicate missing negative reinforcement. The flexural resistance (negative moment) transverse to the girders is negligible and the shear resistance is reduced because of the slot cut in the deck. The rails were removed in 1984 and the rail slot was filled with “shrinkage compensated concrete” (a cementitious grout). Reinforcing steel was not added to the section. The principal tension stress field in this area is perpendicular to the slot wall surface and will cause the grout to separate from the original concrete (producing a vertical crack). NFESC proposes reinforcing upgrades for negative moment over the rail girders.

Figure 9. Cross section detail of main deck above rail girders after rail removal.

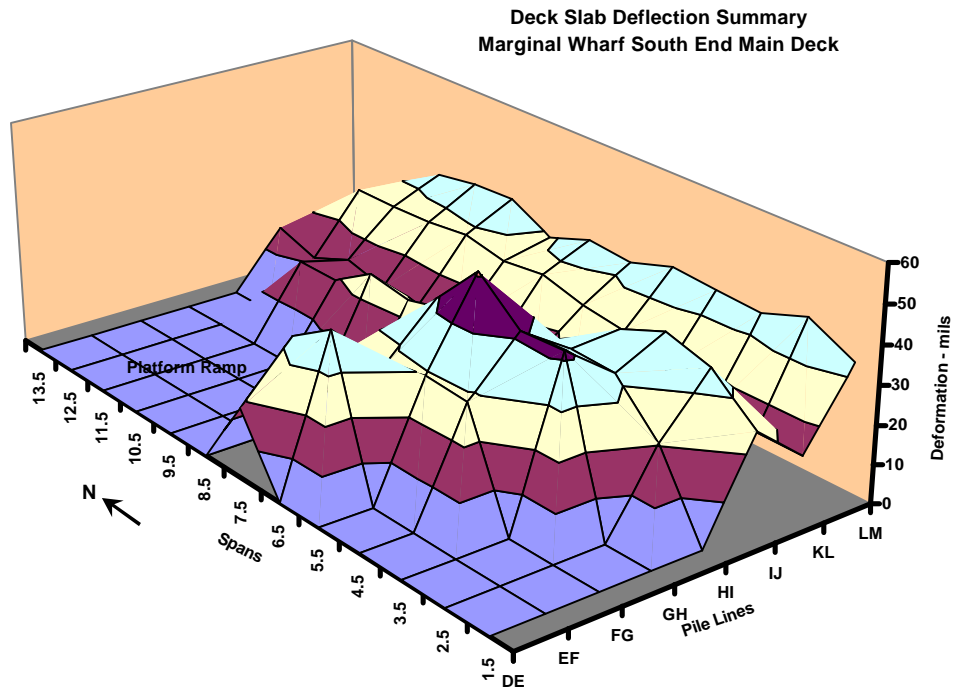
The deck areas at the bases of the ramps also demonstrate softening and cracking due to repeated overloading (Figures 29 and 37).

Figure 29. ILM maximum deflection response summary. Deck slab of south end south pier main deck.

TRIREFAC may want to also consider the cost effectiveness of adding additional strength to the soft areas at the base of the ramps, across the boundaries of deck modifications, and in areas transverse cracking. The latter two will have to contend with severely deteriorated concrete, which must be removed before attempting to add reinforcement.

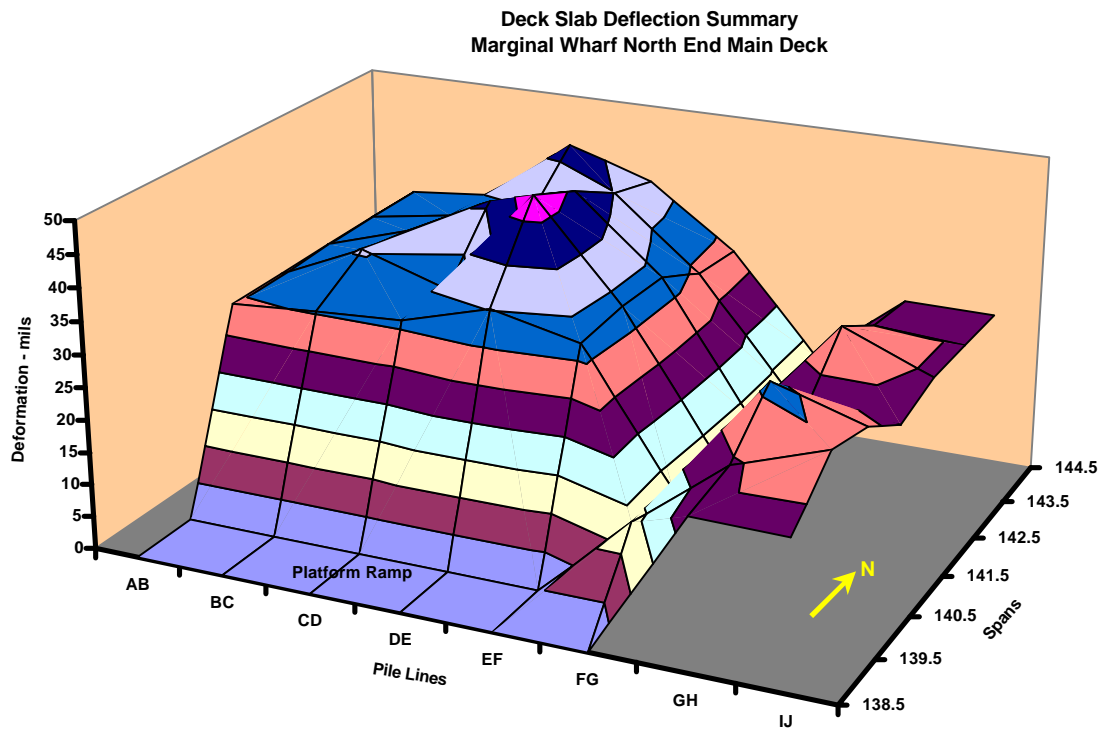
Figure 37. ILM maximum deflection response summary. Deck slabs of wharf north end.

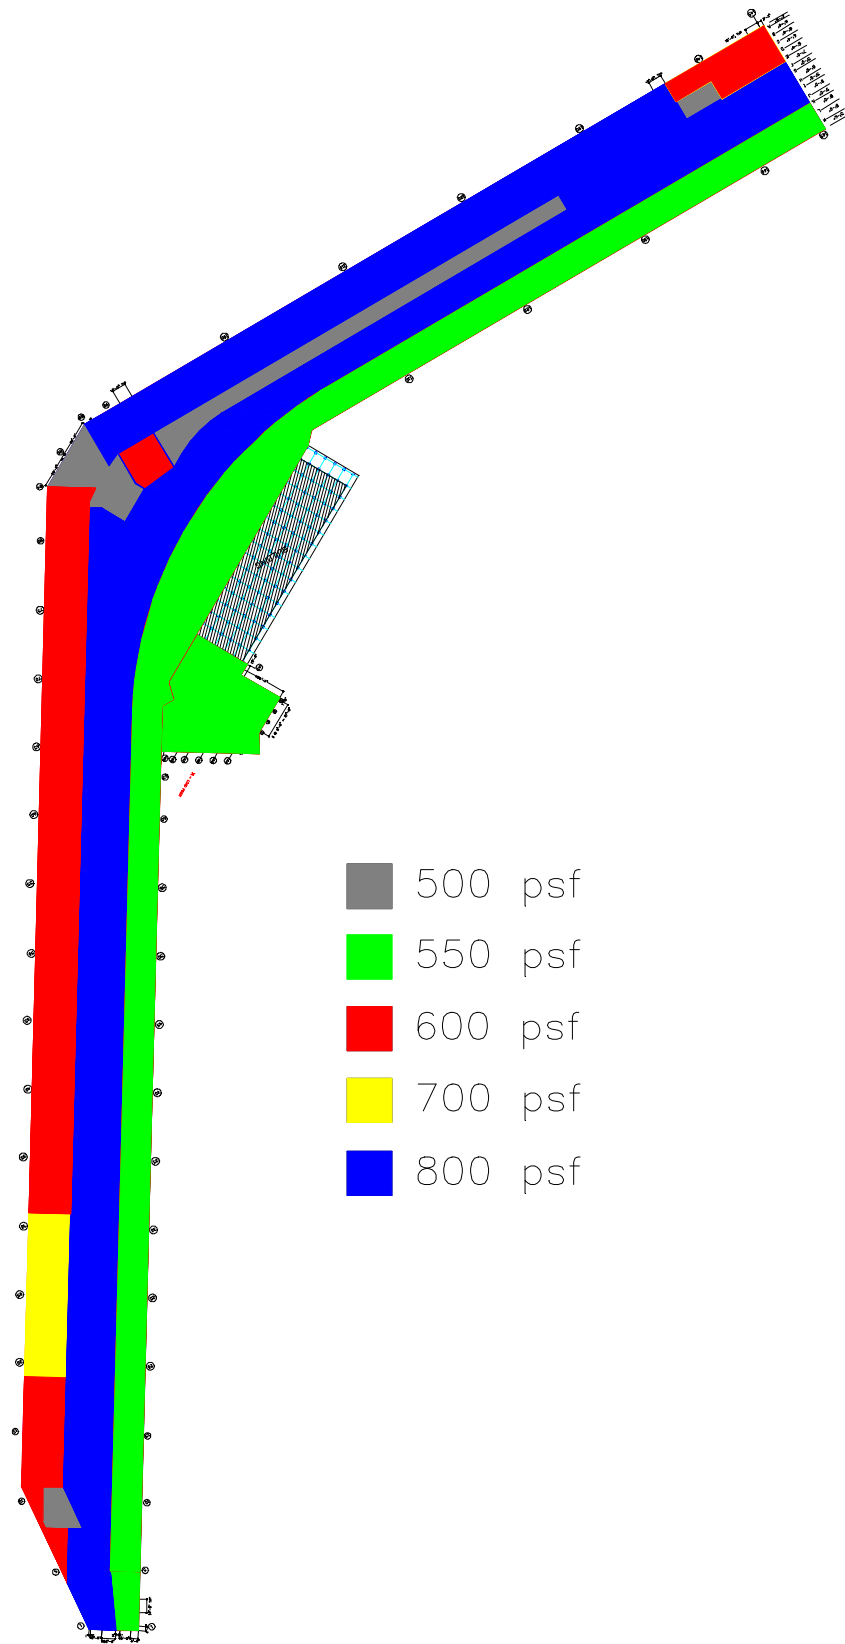
Figure 49. Schematic of allowable uniform load.

Recommended patch load limitations are tabulated in Table 2. Recommended uniform loads are graphed in Figure 49. A general restriction should be enforced on all original deck slabs wherein the maximum single wheel load does not exceed 20 kips for wheel spans greater than 10 feet and axle widths greater than 8 feet. Tandem axle (axles space of 54 inches) wheel loads should not exceed 16 kips (32 kip axle load). Crane speed limits should be set at 5 MPH while on the decks to minimize dynamic loads. The Grove RT880 wheel loads exceed ACI structural capacity of the deck slabs and should not be operated on the Marginal Wharf. Cranes and heavy trucks should be separated by a distance such that wheels from

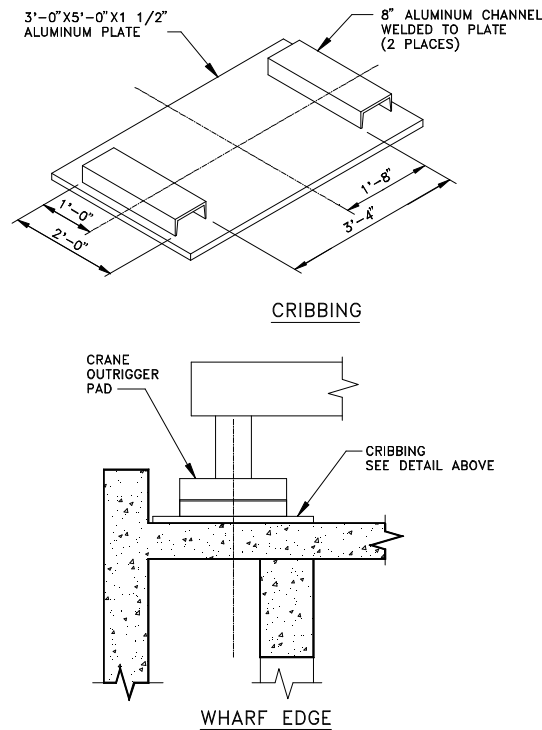
Figure 50. Aluminum cribbing.

We recommend aluminum cribbing replace the wood cribbing now in use. An example aluminum cribbing plate is shown in Figure 50. Steel cribbing proposed by Johnson Controls in August 1992 is also satisfactory. Cribbing should be considered for all outrigger loads in excess of 100 kips.

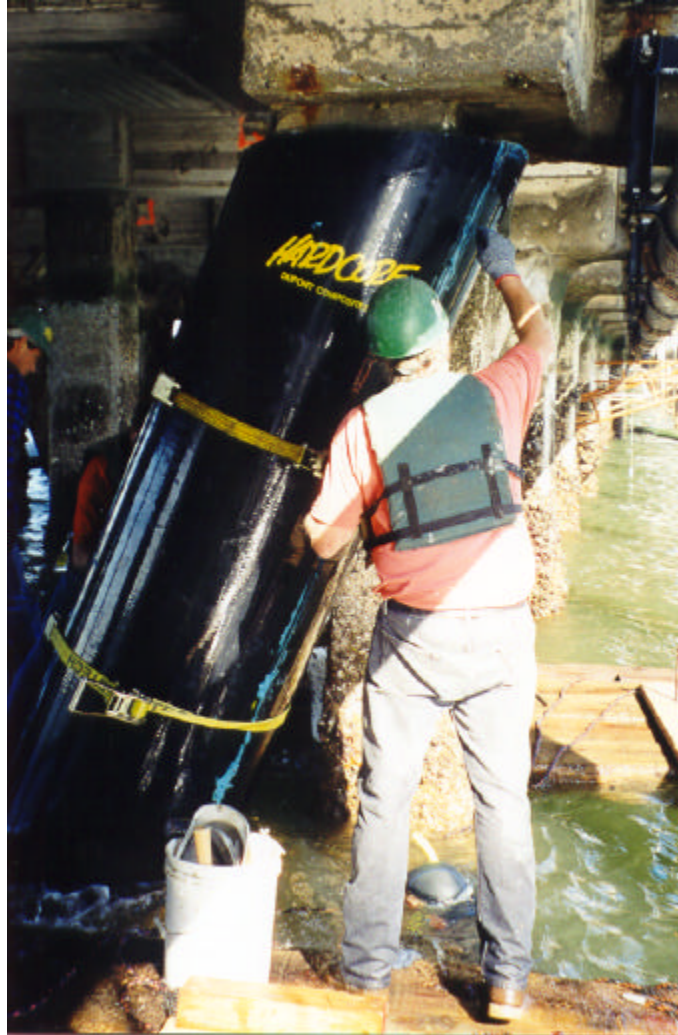
Figure 54. Placing cylindrical composite shell around rectangular concrete pile.

Composite shell encasement is an attractive alternative to replacement if the steel reinforcement retains at least 80 percent of its cross sectional area. This technique employs single and two piece preformed fiberglass reinforced vinylester shells to encase the damaged areas of the piles with shrink resistant epoxy grout or concrete injected or pumped between the shell and the existing pile (Figure 54). The grout will restore the concrete cross section and the shell will increase the confinement strength of the concrete. NFESC has employed shells with a circumferential (confinement) strength of 4 kips/inch at a maximum strain of 0.2 percent and a longitudinal strength of 1 kip/inch.

The diameter of the laminate shell must be at least 28.5 inches so that it will encase the 18-inch square pile and leave space for the grout. The shells should be long enough to extend from the pilecaps down beyond the damaged area. Laps and connections must be able to develop the full, circumferential, shell strength and stiffness. Piles must be cleaned of all marine fouling and loose concrete. The concrete cover of existing steel reinforcing does not need to be removed unless the steel is corroded, then the steel must be exposed and cleaned. The shells should be configured to allow placement within 1 inch of the pile cap.
